NBS SPECIAL PUBLICATION **592**

# An Investigation of the Miyagi-ken-oki, Japan, Earthquake of June 12, 1978

Bruce R. Ellingwood, Editor

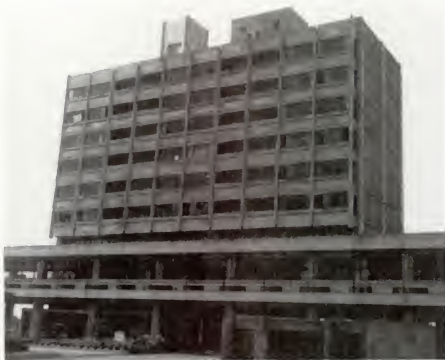
Tohoku University is situated in the northwest part of Sendai, in the district of Aramaki, an area of hills and steep terrain. The Engineering Building is a reinforced concrete framed structure and is built on a reasonably flat area, but a steep cliff falls off close to the rear of the building. Figure 4.4 is a photograph of the central 9-story tower and also shows the two lower levels which cover a larger plan area. A floor plan and two elevations are shown in Figure 4.5. Two SMAC-M instruments are installed in the building, at ground level (there is no basement), and at the 9th floor level. They are on the same vertical line, against an exterior wall of the central tower, as shown in Figure 4.5. These instruments record on FM analog tape, and functioned correctly during the earthquake.

Engineering Building,  
Tohoku University,  
Aramaki, Sendai.

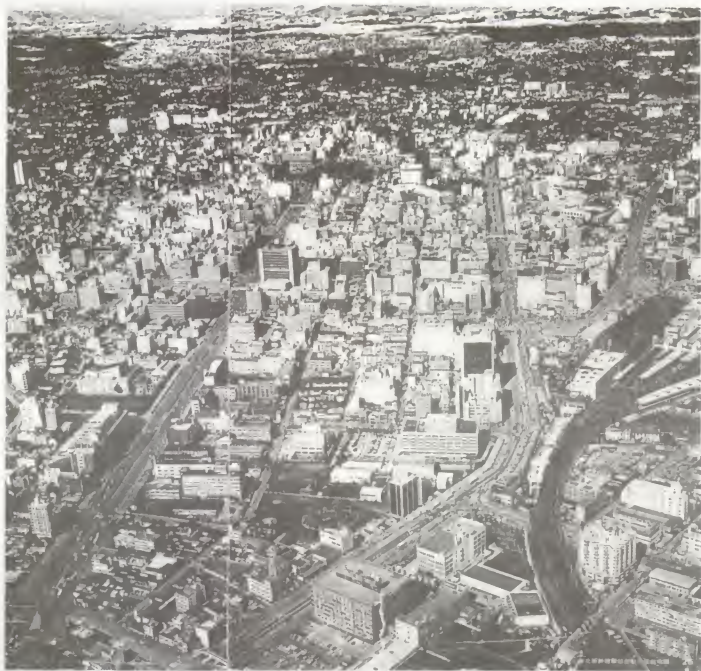
Figure 5.1 View of the downtown area of Sendai (Tohoku Electric Power Company photograph).

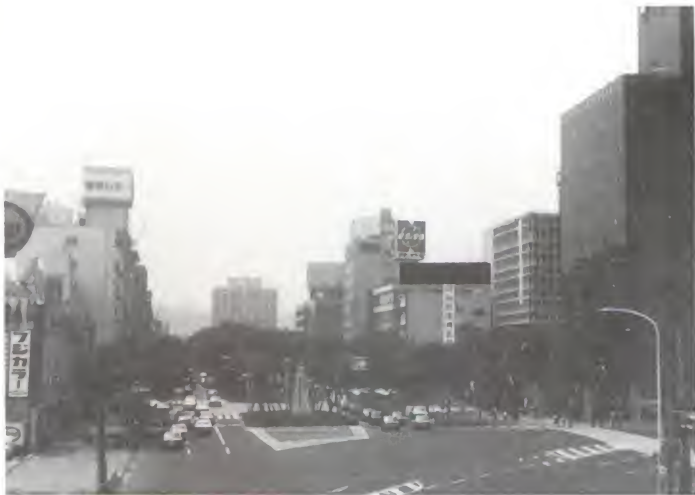
Figure 5.2 Typical buildings of the downtown Sendai area.

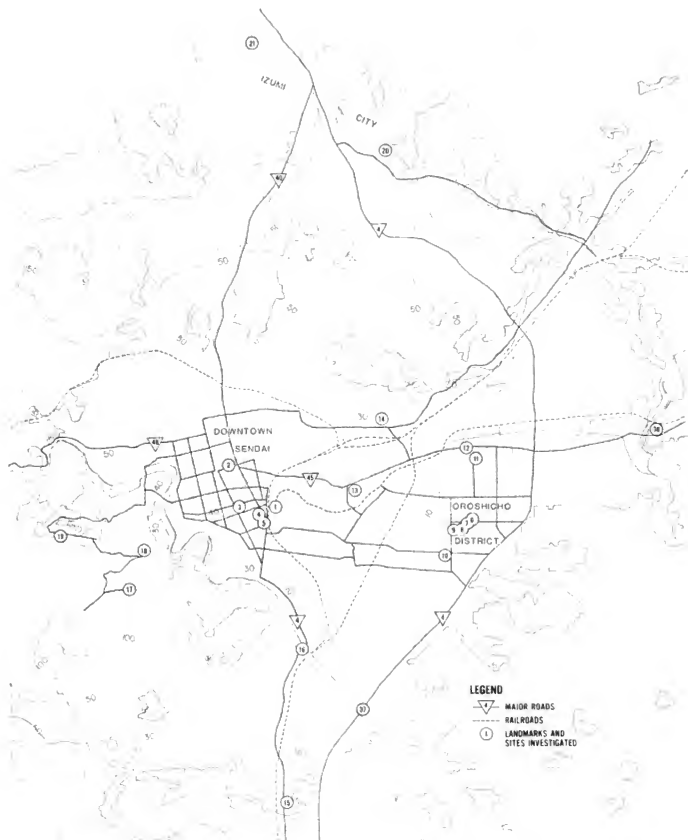
Figure 5.3 Map of Sendai City, showing major landmarks and sites of damaged structures. See Table 5.1 for identification

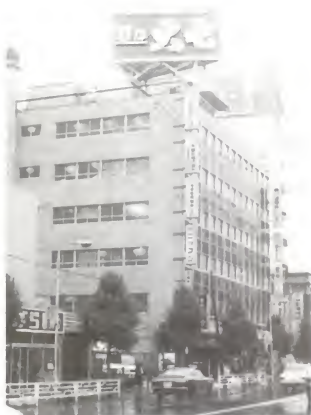
Figure 5.4 Minami Machidori Building, Sendai. The cracking to the brick veneer is typical for many similar buildings in the city.

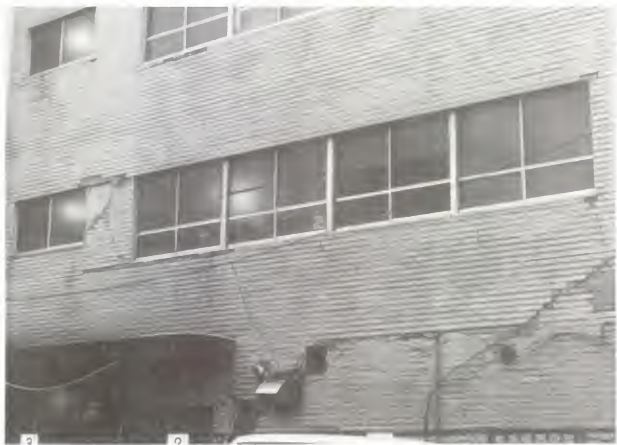
Figure 5.6 Second Eastern Building Company Building, Sendai. A typical modern building in Sendai; the only apparant damage to the glazed tile veneer on the exterior was cracking on spandrels and shear walls.

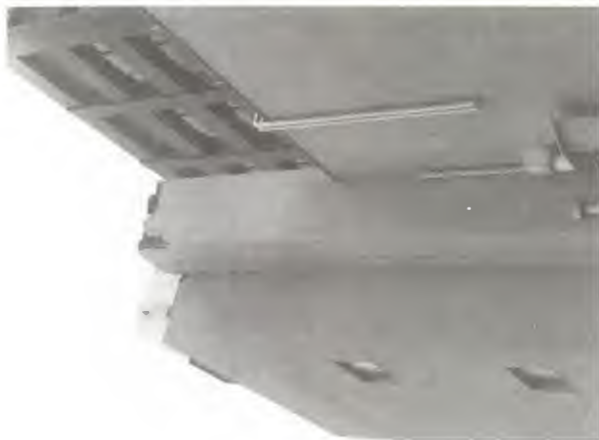
Figure 5.9 Downtown Sendai. Reinforced concrete chimney failure.

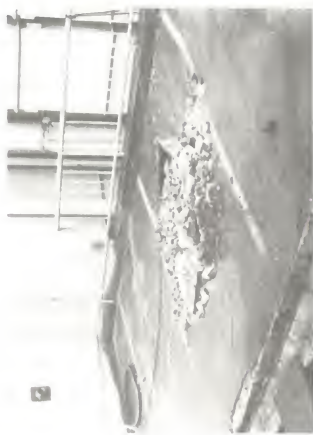
Figure 5.10 Impact area of chimney failure (see Figure 5.9)

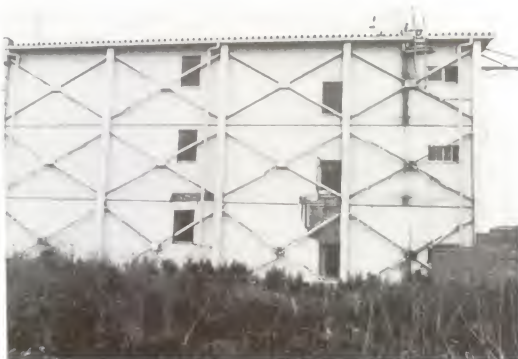
Earthquake resistance in steel buildings is provided either through the use of moment-resisting frames or through diagonal bracing. When braces are used as earthquake resisting elements, it is normal practice to design them so as to carry all of the horizontal force. An example of such a structure is a steel framed furniture warehouse on the outskirts of Sendai shown in Figure 5.11. There were many examples where the bracing members buckled under stress reversal or the connections failed. A number of the transverse diagonal braces used in this warehouse sheared at their bolted cross connections (Figure 5.12).

Figure 5.11 A damaged steel-framed furniture warehouse on the outskirts of Sendai.

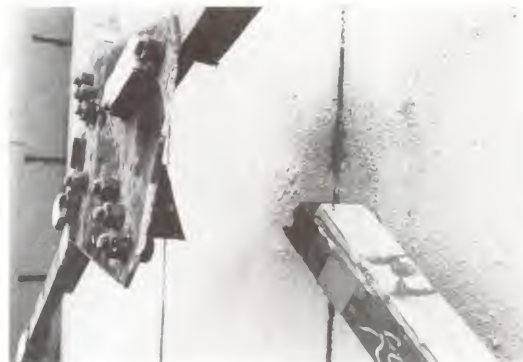
Figure 5.12 Detail of failure in transverse diagonal braces.

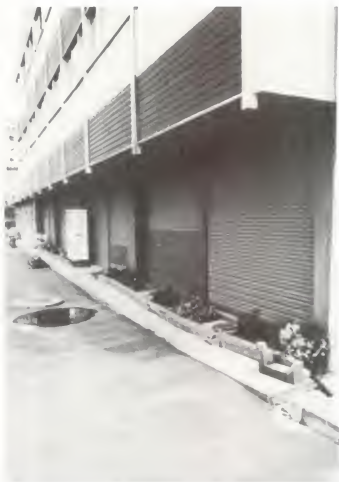
There was extensive evidence of ground settlement in the Oroshicho area, including settlement of asphaltic concrete sidewalks and slumping around building foundation walls, as in Figures 5.20, and 5.21.

Figure 5.20 Oroshicho area, Sendai.  
Ground settlement.

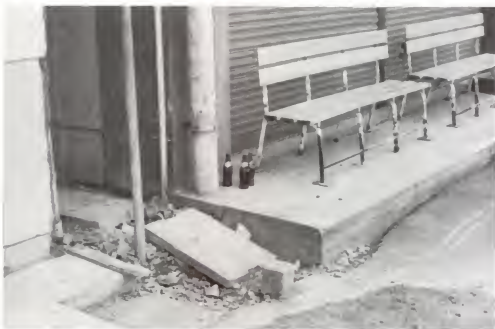
Figure 5.21 Oroshicho area. Sidewalk damage  
caused by ground settlement.

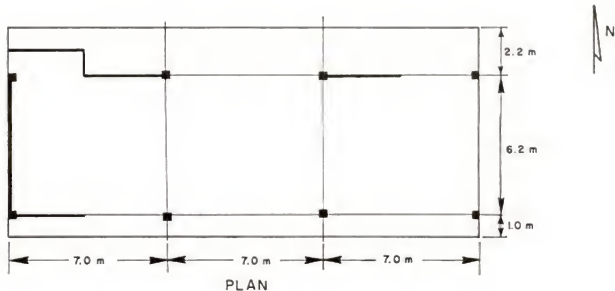
Maruyoshi Building (No. 6, Figure 5.3). This was a three-story reinforced concrete frame building, one span by three, with the long axis of the building running in the E-W direction. There was a 2 m overhang on the north side of the structure (Figure 5.22). The wall shown at the west end was continuous from the second-story on up. The building had a flexible first-story. The building suffered extensive damage to the first-story (Figure 5.23) and, as shown in Figure 5.24 was tilting toward the north. The first story columns on the south side of the building failed in shear due to the strong N-S motion. A detail of the beam-column joint where the second-story floor beam frames into the first-story column is shown in Figure 5.25. Column ties appeared to be spaced at about 300 mm. The shear wall on the west end of the structure appeared to be undamaged. Unfortunately, this caused the structure to behave as an inverted pendulum and caused the first-story columns to accept even more shear. Note the use of the undeformed bars in the beam-column joint (Figure 5.25).

Figure 5.23 Maruyoshi Building, view from the northwest. This three story reinforced concrete frame, one span by three, suffered almost total collapse of the first floor.

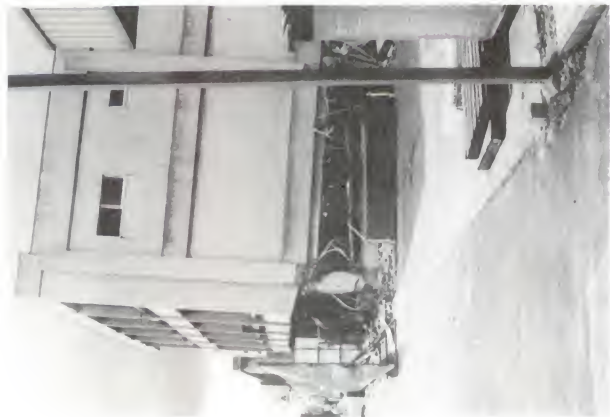
Figure 5.24 Maruyoshi Building, view from the east. Failure of first story columns occurred in shear.

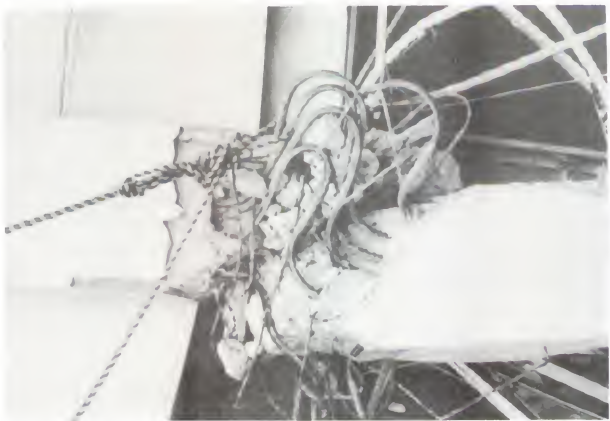
Figure 5.25 Maruyoshi Building. Detail of a joint at the top of a first story column.

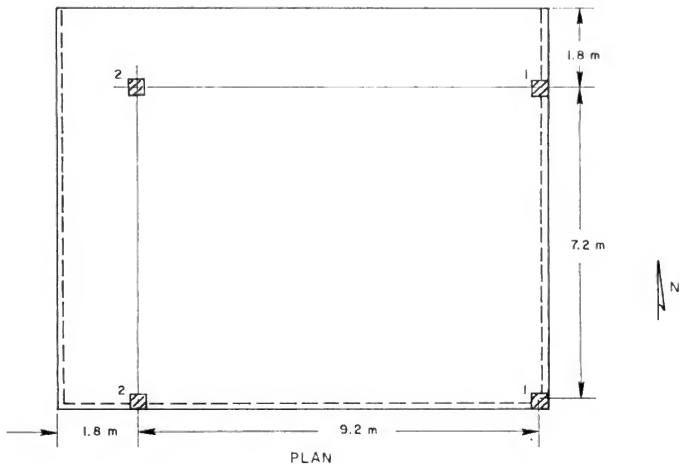
Figure 5.26 Plan and column details of Obisan Building, Oroshecho area.

Obisan Building (No. 7, Figure 5.3). This was a three-story reinforced concrete frame building with one span in each direction (Figure 5.26). The portion of the building which overhung the column line by about 2 m contained a heavy stairwell. There were no openings in the overhanging part of the building, which added to the eccentric mass. Coupled with the strong N-S motion, this caused a failure in torsion as the columns at the west end of the building were unable to withstand the forces resulting from the large eccentric mass. Figures 5.27 and 5.28 show the Obisan Building after the earthquake viewed from the north and south, respectively. It may be observed that the upper stories rotated almost as a rigid body when the first floor columns failed. The first-story of the building had been used as a display area, and was completely open. A detail of the SE column is shown in Figure 5.29 and in the plan. As shown in Figure 5.30, the first floor support beams were practically resting on the ground at the west end of the building. The walls above the first-story suffered extensive cracking during the earthquake, but remained intact (Figure 5.31). The reinforcing bars that can be seen are undeformed.

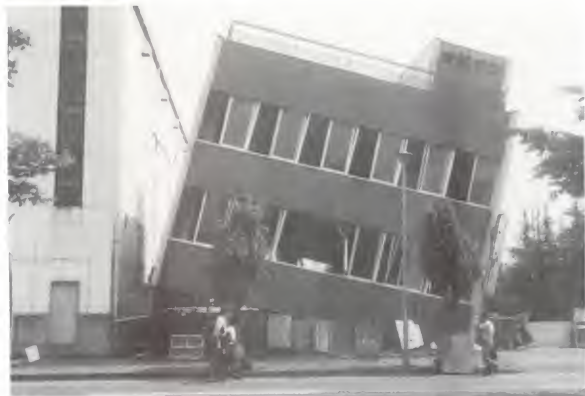
Figure 5.27 Obisan Building, viewed from the North. This three story reinforced concrete frame building had a heavy eccentric stairwell cantilevered over the column line at the right end of the building.

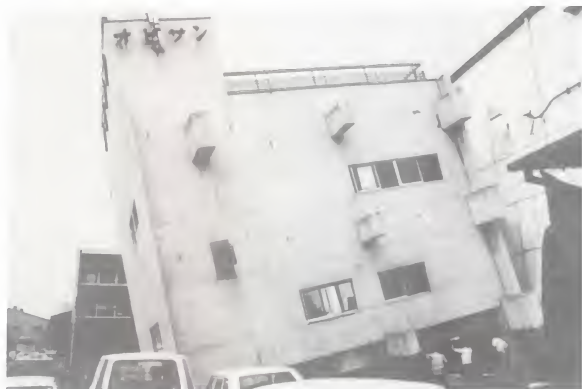
Figure 5.28 Obisan Building, viewed from the south. The upper stories rotated as a rigid body when the first floor column support was lost.

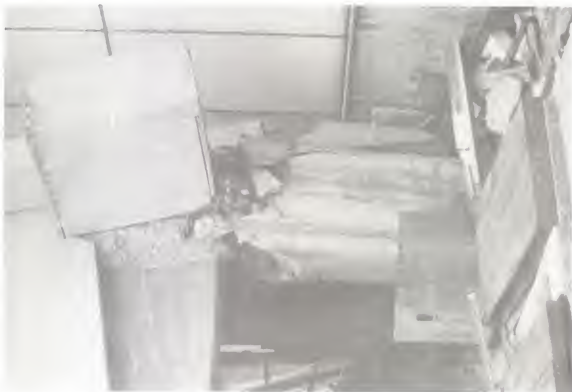
Figure 5.29 Obisan Building, detail of southeast column.

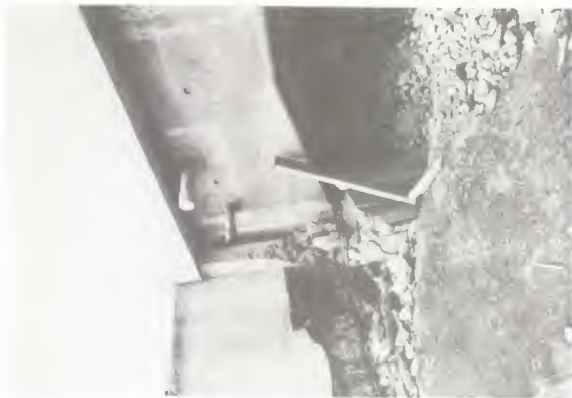
Figure 5.30 Obisan Building, detail of southwest column adjacent to overhang.

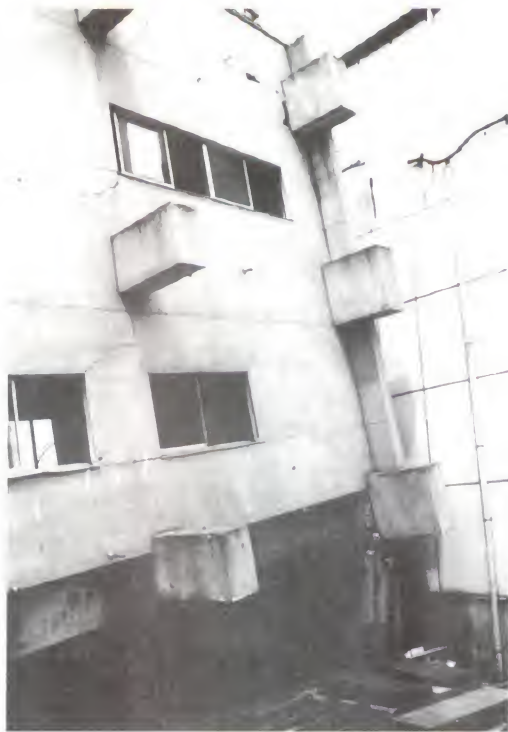
Figure 5.31 Obisan Building, south face. Walls above first story remained essentially intact.

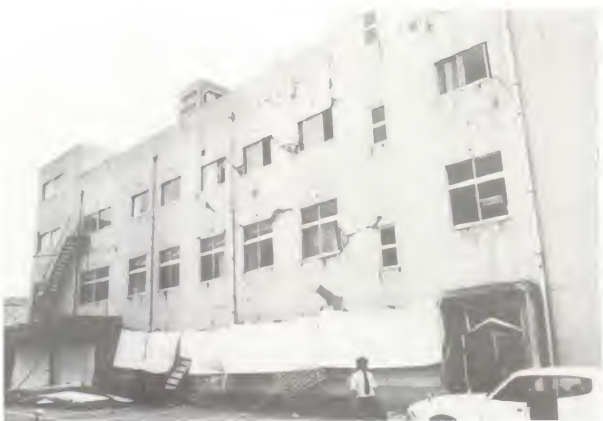
Figure 5.32 Kinoshita Building, Oroshicho area, of Sendai. Extensive diagonal cracking was observed on the east face (rear) of the building.

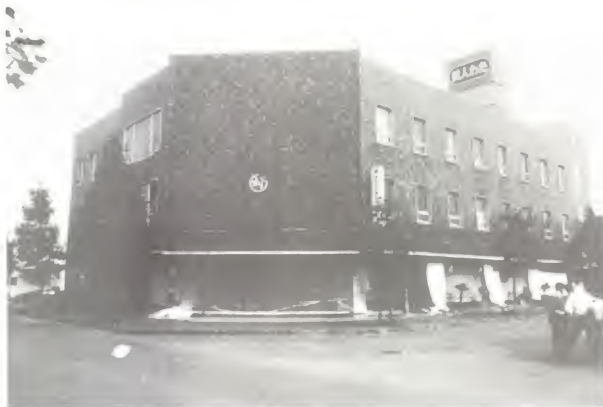
Kinoshita Building (No. 8, Figure 5.3). This three-story reinforced concrete frame building, two spans by six, had its main axis in the N-S direction. As shown in Figure 5.32, there was extensive diagonal cracking on the east face. The first floor on the west side of the building, Figure 5.33, was used as a showroom. Unlike the backside of the building, where the columns were stiffened by spandrels, the columns on the west side were relatively flexible, and there appeared to be very little damage on that side of the building. The brick facing on the west side remained intact. The interior columns on the east side of the building showed large shear cracks and buckling of exposed undeformed bars. A reinforced masonry partition wall also failed here. It is apparent that most of the seismic force was attracted to the relatively stiff east side of the building. In addition, there appeared to be significant settlement of about 100 - 150 mm in the interior of the building on the east side. This, along with the relative stiffness of the east face, would explain the diagonal cracking pattern observed on the east face as well as cracking patterns observed in columns and panels. Failures of this sort were also observed following the Niigata earthquake (Okamoto, 1973).

Figure 5.33 Kinoshita Building. The brick facing on the west side of the structure showed little sign of damage.

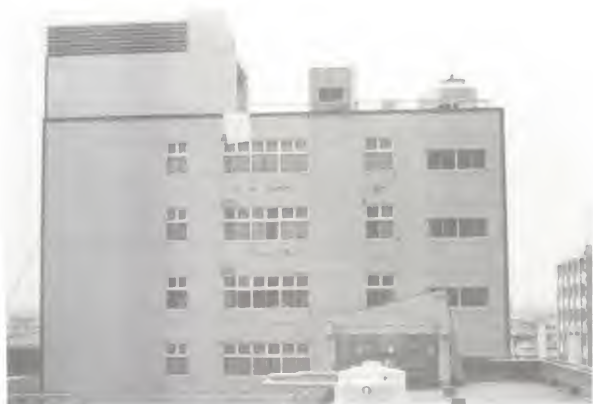
extensive diagonal cracking in the panels between window openings on both east (Figure 5.34) and west faces (Figure 5.35); this damage is especially severe on the west face, as shown in the detail in Figure 5.36. The decorative ceramic brick facing on the north side of the building did not appear to be damaged.

Figure 5.34 Maruhon Building, Oroshicho area, showing shear cracking in the panels on the east face between window openings.

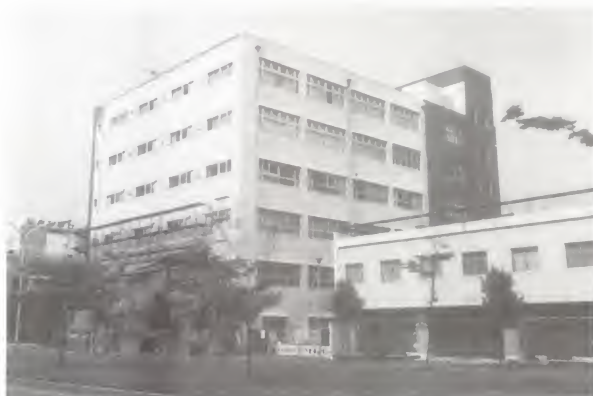
Figure 5.35 Maruhon Building, west face, showing cracking of curtain wall panels.

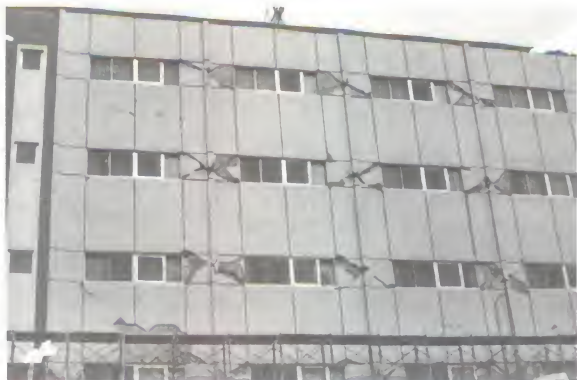
Figure 5.36 Maruhon Building, west face. Detail of the damage to panels between windows.

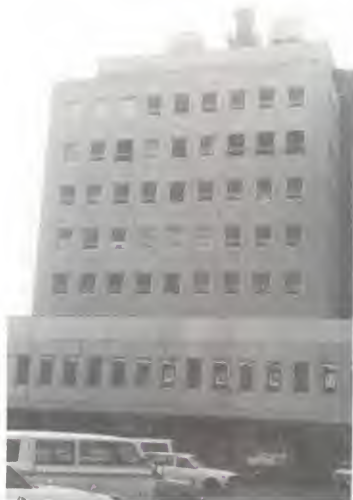
Despite the level of damage in the Oroshicho area, many buildings performed quite well. As an example, Figure 5.37 illustrates a 9-story building which was only slightly damaged. No details about its construction are known.

Figure 5.37 A slightly damaged 9 story building in the Oroshicho area of Sendai.

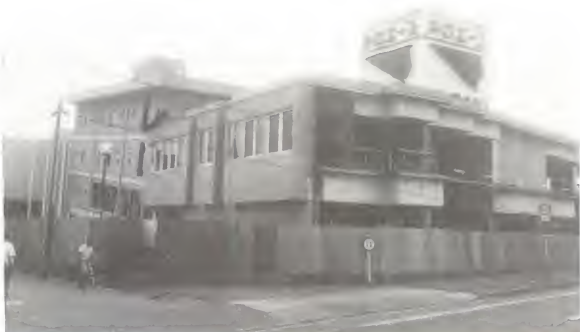
The strong N-S component of the earthquake caused shear failures in the first story concrete columns in the middle building and a collapse at the ground story, causing the entire building to tilt north. This racked the two-story steel frame building forward, causing extensive damage to the steel frame and popping glass panes from showroom windows. The area of impact between the two buildings is shown in Figures 5.39 and 5.40 and 5.41. Figure 5.42 shows a detail of the beam-column joint at the top of the first-story column on the east side of the middle building. The column shear failure extended up into the beam. A detail of the column on the northeast corner of the middle building in Figure 5.43 shows the gross vertical displacement and badly distorted bars in the columns. Unlike the other collapsed buildings in the Oroshicho area, deformed reinforcing bars were used in the Yazaki building. The building service systems between the two impacted buildings were damaged.

Figure 5.38 Yazaki Industries Buildings, viewed from the northeast, Oroshicho area. Portions of three Yazaki buildings are shown. Failure of the reinforced concrete middle building caused it to rack forward against the front steel structure.

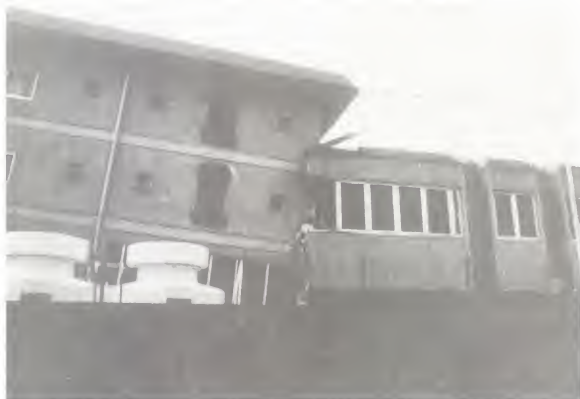
Figure 5.40 Yazaki Industries, showing area of impact between steel and reinforced concrete frames.

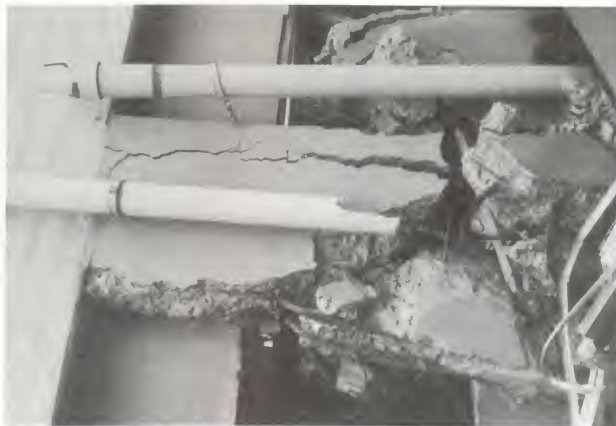
Figure 5.41 Yazaki Industries, showing damage to lower story reinforced concrete column.

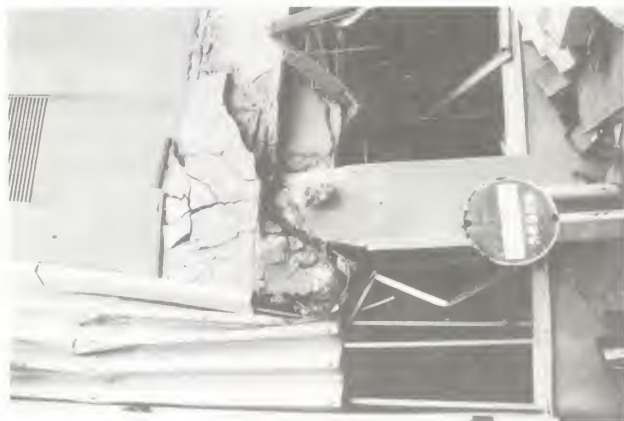
Figure 5.42 Yazaki Industries Building, showing beam-column joint at top of first story column, east side.

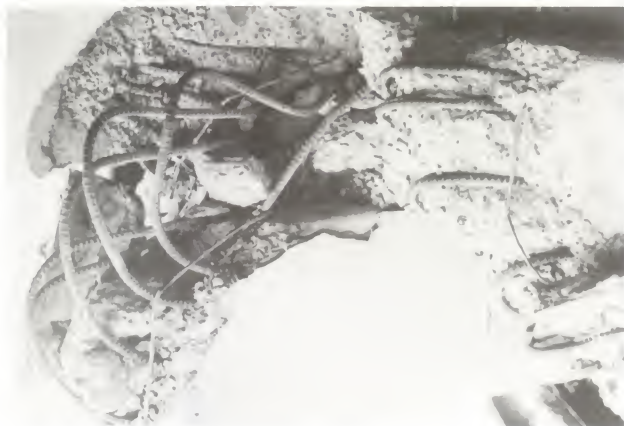
Figure 5.43 Yazaki Industries Buildings. Detail of column shear failure, east side. Note use of deformed bars.

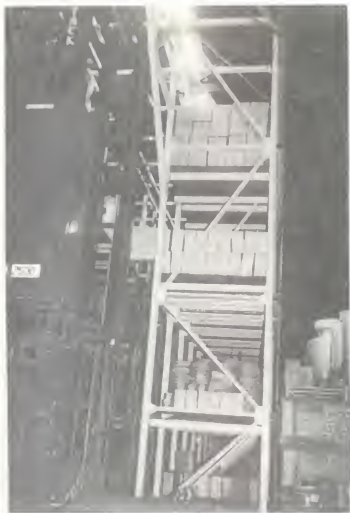
The steel frame warehouse behind the collapsed building (Figure 5.38) did not appear to be damaged. The warehouse contained numerous heavy tubular steel frame storage racks with diagonal braces, as shown in Figure 5.44. The storage racks stand approximately 7 m in height and are anchored to the concrete floor by being bolted or welded to steel plates in the floor. Although none of the racks had collapsed, the bottom diagonal braces appeared to have buckled on several racks, as shown in Figure 5.45.

Figure 5.44 Yazaki Industries warehouse building. A number of multi-level tubular steel storage racks had damaged transverse braces at ground level.

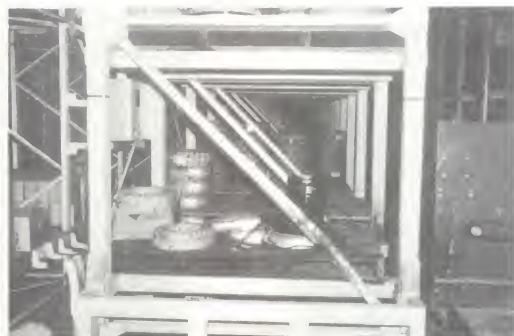
Figure 5.45 Yazaki Industries warehouse. Detail of diagonal brace at bottom of storage rack.

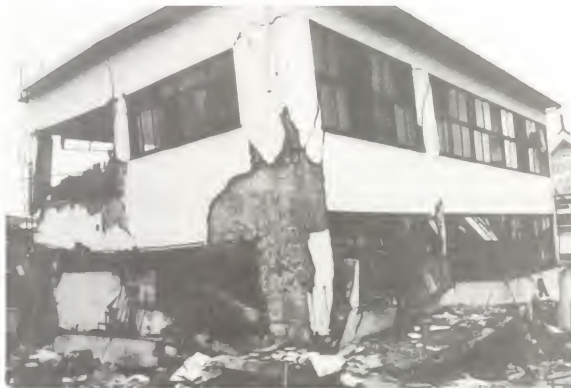
Paloma Building (No. 12, Figure 5.3). This reinforced concrete frame structure faced north and was located on Japan National Highway 45. It was a three-story rectangular building, two spans by three, with a shear wall on the west end of the building. The first floor was used for display, and had a large open area on the north and east side of the first floor. The main axis of the building ran in the E-W direction. Figures 5.4 and 5.48 show the Paloma Building viewed from the east following the earthquake. Failure occurred in the columns at this end of the building, causing the building to tilt toward the east. However, the shear wall at the west end of the building was also badly damaged (Figures 5.49 and 5.50). It is likely that the eccentricity caused by the presence of the shear wall on only one end of the building caused a torsional mode of failure for the structure.

Figure 5.47 Paloma Building - Viewed from the east. Collapse occurred at the east end of the building.

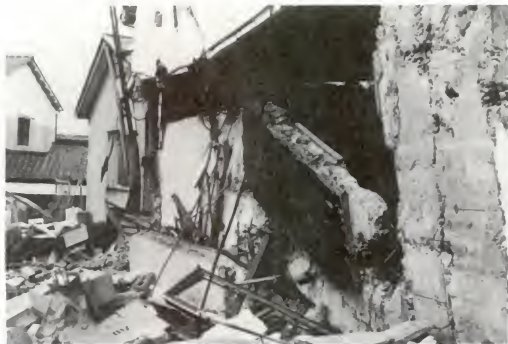
Figure 5.48 Paloma Building. - Detail of first story, east end, showing inferior quality concrete.

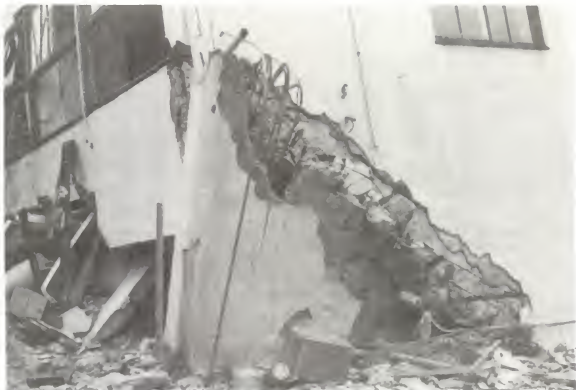
Figure 5.50 Paloma Building, detail of shear wall on west end of building.

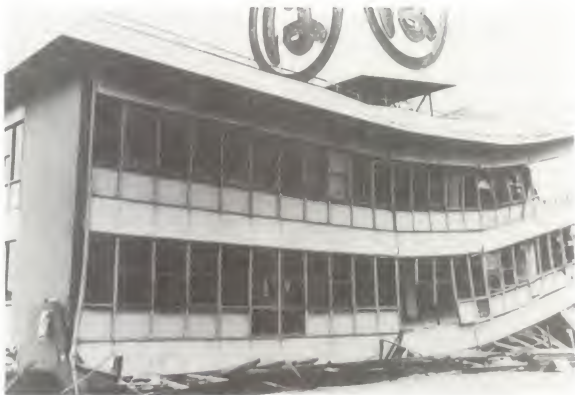
Taiyo Fisheries Plant (No. 11, Figure 5.3). This was a three-story building with a reinforced concrete frame, one span by five, the main axis of which was in the N-S direction. There were shear walls on the north and south ends of the structure. As shown in Figures 5.51 and 5.52, the first-story columns in the middle of the building failed, causing the central portion of the building to collapse but leaving the ends standing. The shear walls at the north end of the structure (running in the E-W direction) were badly cracked. At the time the site was visited, the building was being demolished.

Figure 5.51 Taiyo Fisheries Plant, viewed from the west. The first story columns in the center portion of the building failed, leaving the ends of the building standing. (Japan National Land Agency photograph)

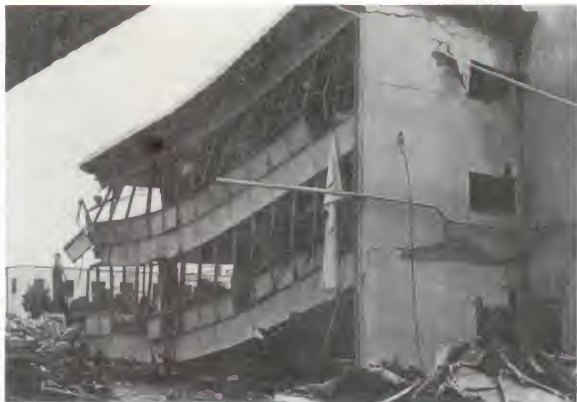
Figure 5.52 Taiyo Fisheries Plant, viewed from the northeast. The reinforced concrete shear wall on the north end was badly damaged.

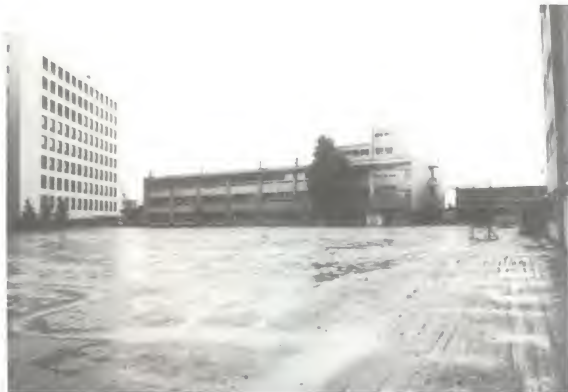
The school is located on the east side of the city where the soil conditions are relatively poor. The east side of the building sits on a small bluff approximately 6 m in height. This may have amplified the ground motion at the site. The school was badly damaged by the earthquake and has been closed.

Figure 5.53 Tonan High School, west face. A small bluff on the opposite side of the building may have amplified ground motion. The adjacent structures were undamaged.

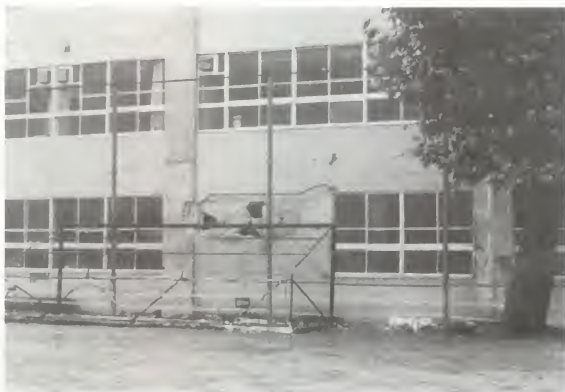
Figure 5.54 Tonan High School - Detail of damage to west face.

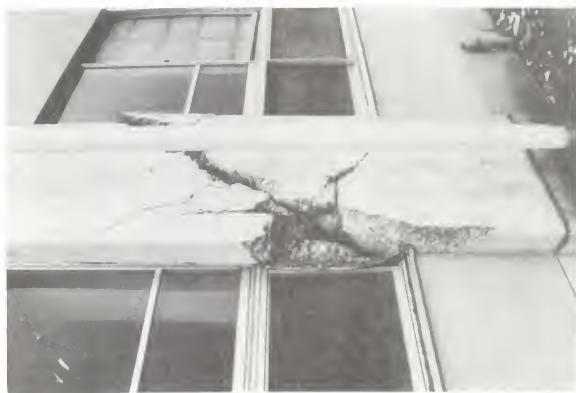
The west face elevation and the school yard are shown in Figures 5.53 and 5.54. The exterior first-story columns were all severely damaged, the shear cracks occurring just above the infill panels, (Figures 5.55 and 5.56). In many cases the width of the cracks was over 20 mm. The upper story columns showed less shear cracking. The interior columns did not appear to be damaged. They lacked the stiffening provided by the infill panels. A corridor ran along the length of the building in the middle, and the shear walls were not continuous across the width of the building. Undeformed reinforcing bars were used in the columns. The ties in the exterior columns were spaced at roughly one-half the maximum dimension of the column.

Figure 5.55 Tonan High School. Detail of shear cracking in exterior column above partial infill panels on east face

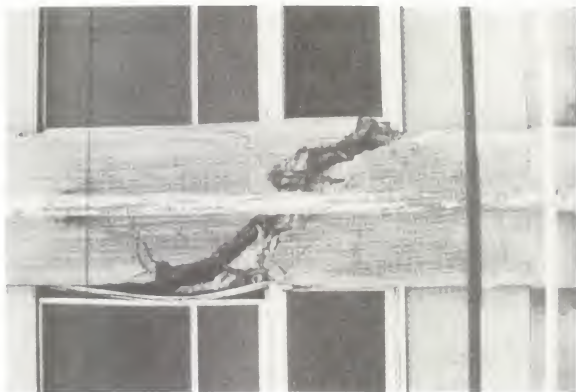
Figure 5.56 Tonan High School. Detail of column damage, exposing reinforcement.

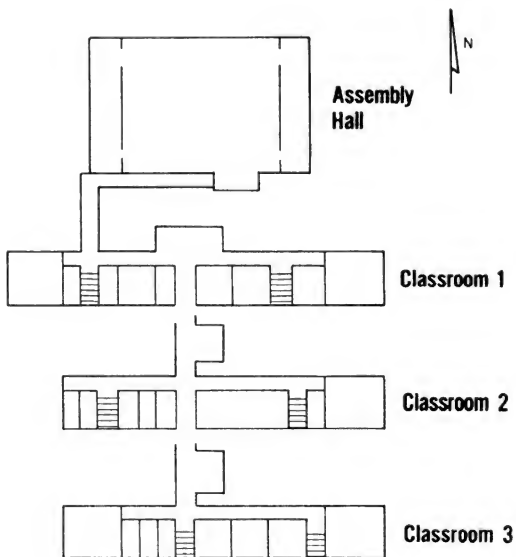
Figure 5.57 Izumi High School, Izumi City. Plan view of steel frame assembly hall and three reinforced concrete classroom buildings.

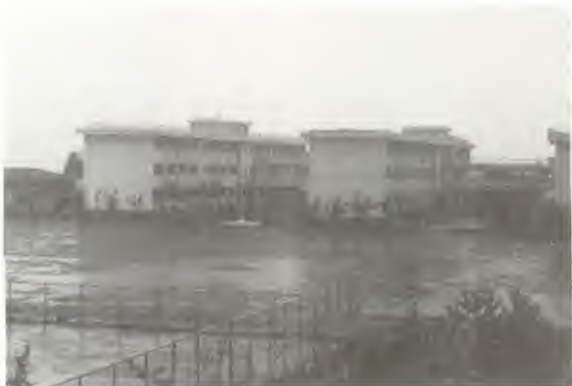
Figure 5.58 Izumi High School. Three adjacent reinforced concrete frame buildings with shearwalls suffered minor damage.

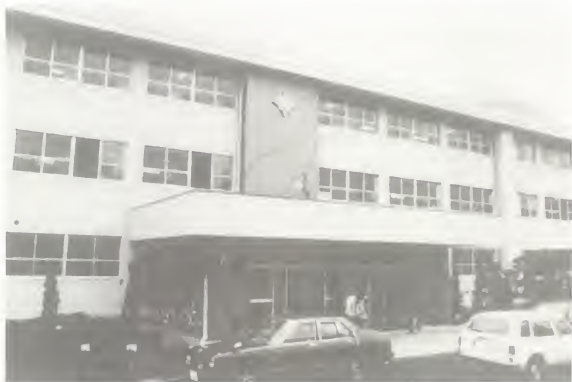
Figure 5.59 Izumi High School. Detail of panel over north entrance to building 1.

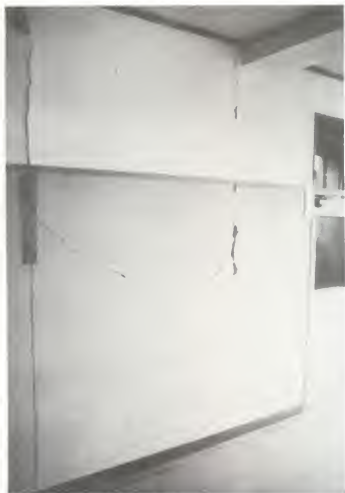
Figure 5.60 Izumi High School. An interior corridor wall in classroom building 1 aligned in the longitudinal direction of the building.

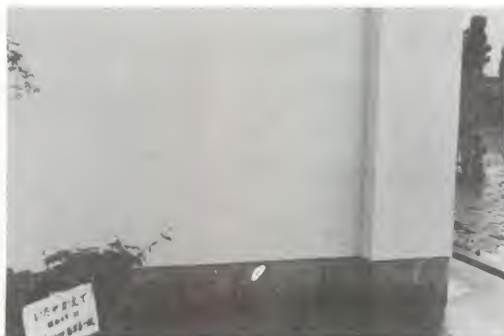
Figure 6.61 Izumi High School. The diagonal crack in the exterior wall shows that foundation settlement or uplift took place at the corner.

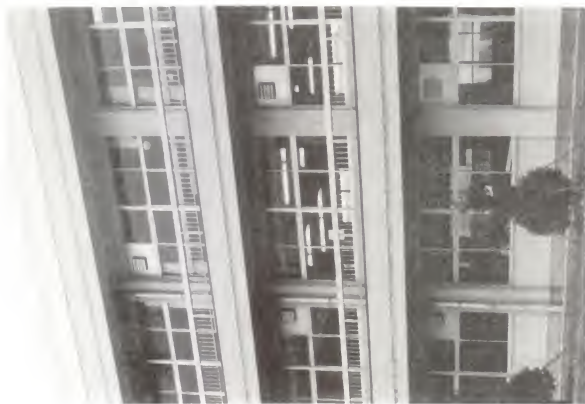
Figure 5.62 Izumi High School, typical classroom building, south face. This side of the building, which is relatively open, suffered little damage.

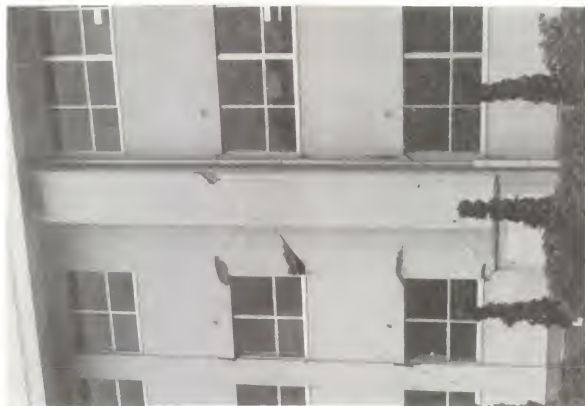
Figure 5.63 Izumi High School, typical classroom building, north face. All faces with the larger infill panels were similarly damaged.

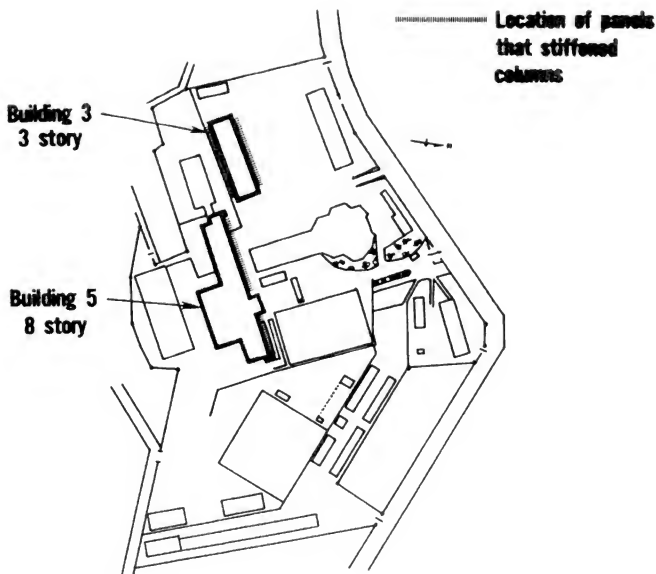
Figure 5.64 Tohoku Institute of Technology, Sendai, plan of campus. Hatching along walls of buildings 3 and 5 shows location of severely damaged columns.

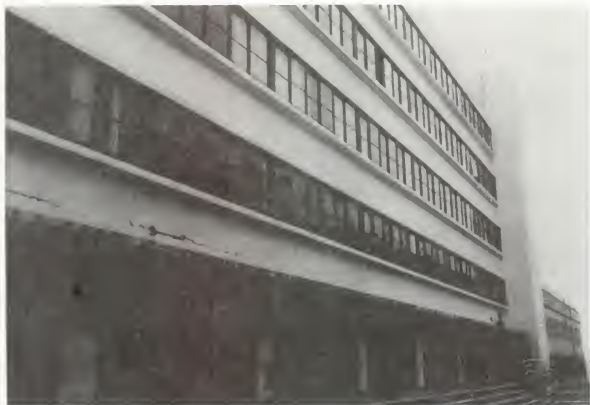
Figure 5.65 Tohoku Institute of Technology. Partial view of the entrance and north facade of building 5. Most serious damage to columns occurred on this side of the building.

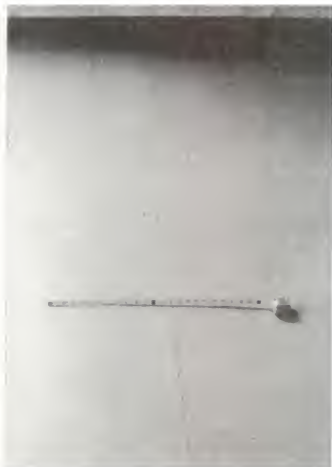
Figure 5.66 Tohoku Institute of Technology. Typical cracking of floor diaphragms at the sixth floor level, building 5.

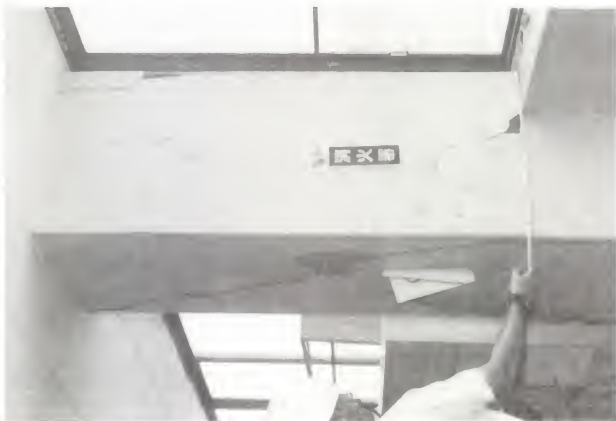
Figure 5.67 Tohoku Institute of Technology. Typical damage to seventh story column of the north facade of building 5.

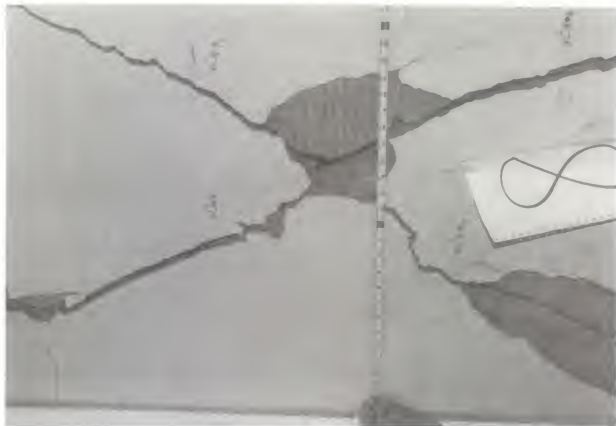
Figure 5.68 Tohoku Institute of Technology, Building 5. Detail of column damage.

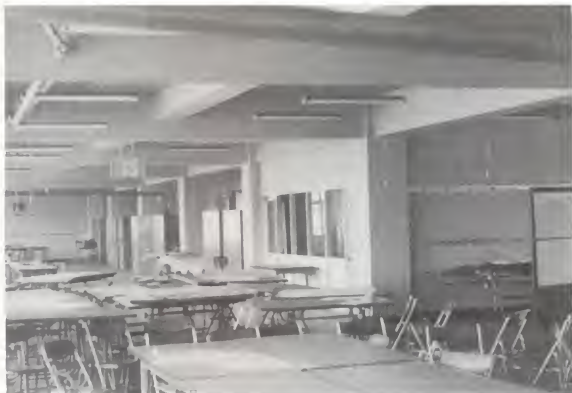
Figure 5.69 Tohoku Institute of Technology, Building 5. Seventh story interior, looking towards the lightly damaged southern exterior frame.

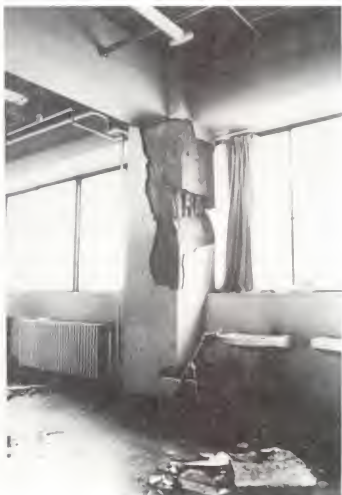
Figure 5.70 Tohoku Institute of Technology, Building 5. Damage to column on north side of third story. The tie spacing is 25 cm.

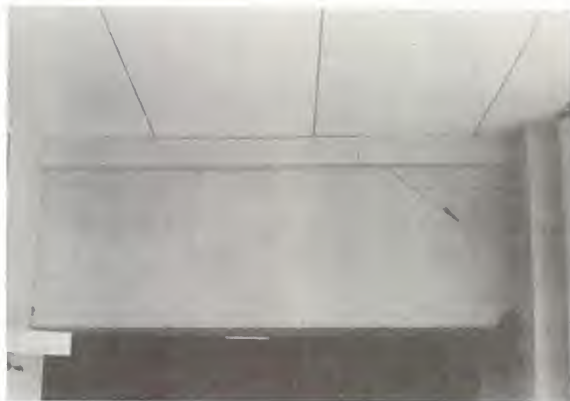
Figure 5.71 Tohoku Institute of Technology, Building 5. The tie beam over a sixth floor corridor connecting two shear walls shows diagonal cracks at both ends.

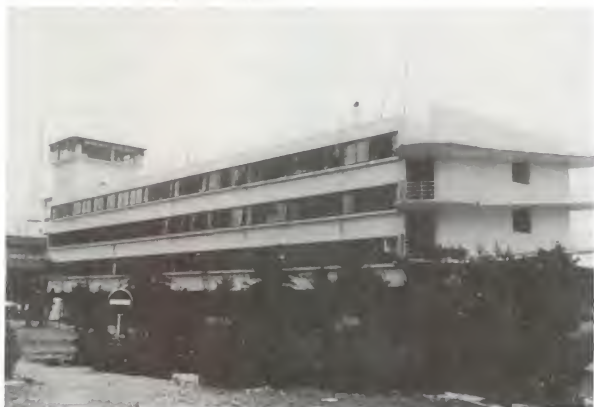
The northeast facade of building 3 is shown in Figure 5.74. This is a four-story reinforced concrete frame building, ten spans by two. While the relatively flexible interior columns were undamaged, all of the exterior columns on the first-story cracked in shear just above the infill panels, as shown in Figure 5.75. Figure 5.76 illustrates this more clearly at one of the first-story columns on the northeast side of building 3. As can be seen, the reinforcement is undeformed. We were informed that core samples taken out of the spandrels showed no apparent damage to the concrete.

Figure 5.75 Tohoku Institute of Technology, Building 3. Damage to the ground floor columns on the south side of the building. Similar damage is present on the opposite side of the building.

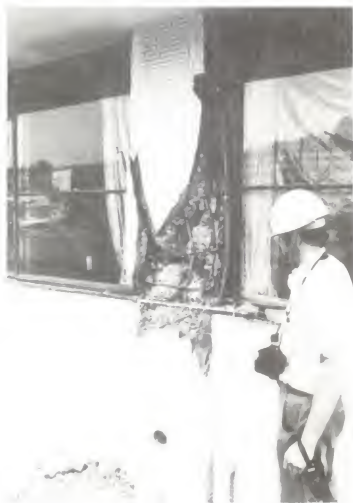
Figure 5.76 Tohoku Institute of Technology, Building 3. Typical damage to ground story exterior column on north side of building.

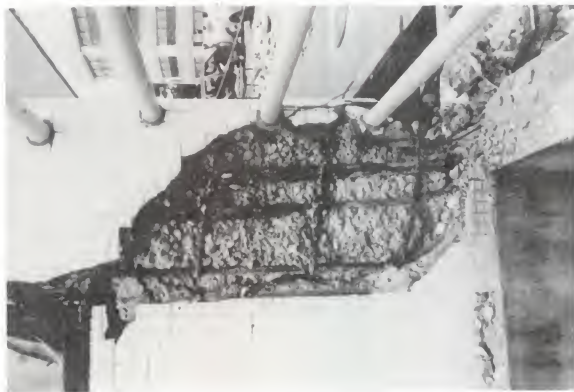
Around the entrance on the east side of building 3 and the southeast corner of its first-story, large areas of the tile facing and concrete underneath had spalled off, exposing the reinforcement (Figure 5.77). At this location, the vertical reinforcing bars were bent manually during construction in order to force them to conform to the building working drawings. The reinforcement appeared to have less than 10 mm concrete cover. The interior walls of building 3 showed extensive diagonal cracking (Figure 5.78). However the interior columns were apparently not damaged.

Figure 5.77 Tohoku Institute of Technology, Building 3. Detail of one of the damaged columns of the exterior frame on the south side of the building showing reinforcing details.

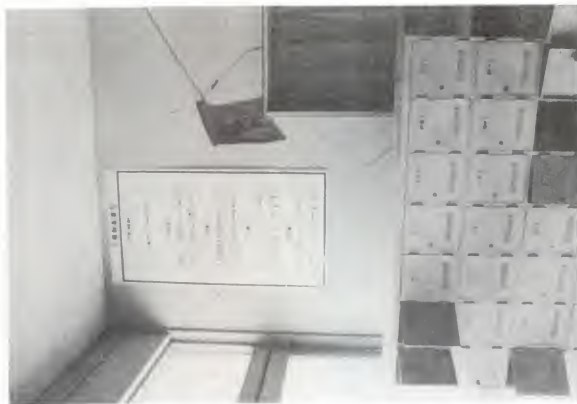
Figure 5.78 Tohoku Institute of Technology, Building 3. Interior surface of shear wall at east end of building.

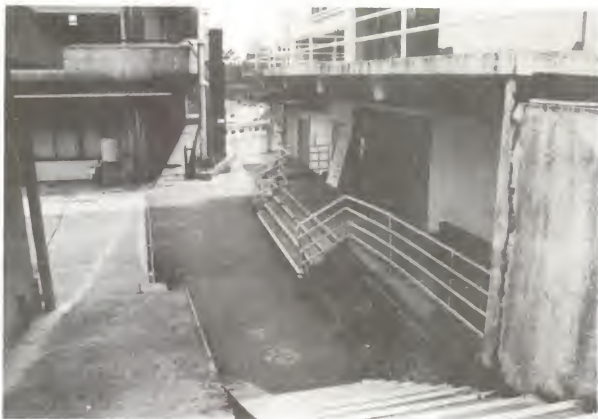
Figure 5.79 Tohoku Institute of Technology, walkway and north entrance of building 5 shows settlement of backfill along length of building.

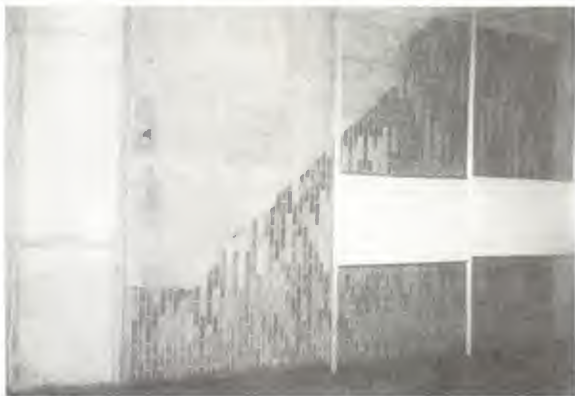
Figure 5.80 Tohoku University Engineering Building. Damage to glazed tile veneer of shear wall at ground level.

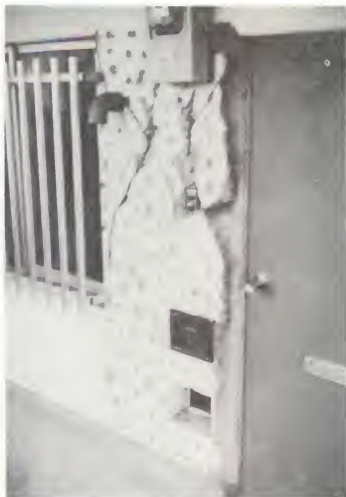
Figure 5.82 Sunny Heights Apartment Building. Detail of cracking of panels adjacent to doorways. Such cracking was typical at all levels on the east facade of the structure.

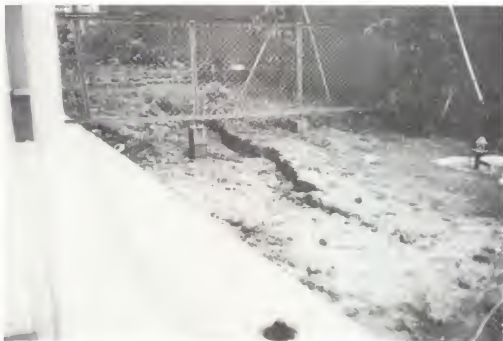
Figure 5.84 shows an example of the ground cracking resulting from subsidence in one of the hilly areas in Sendai. The loss of foundation support has caused extensive cracking in the building walls. In Figure 5.85, the front steps and breezeway have separated some 30 cm

Figure 5.84 Sendai. Damage to single family residence due to loss of foundation support. (Japan National Land Agency photograph)

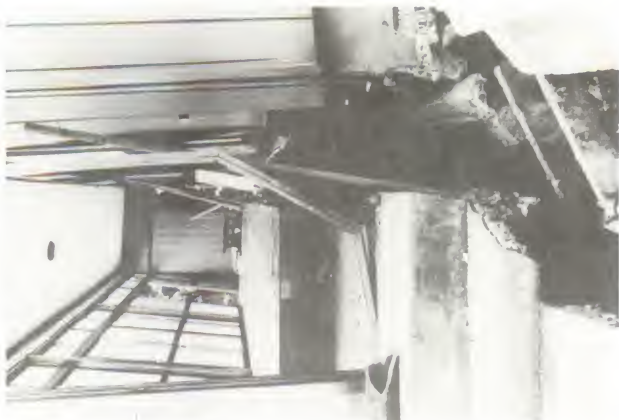
Figure 5.85 Sendai. Damage to single family residence due to ground settlement. (Japan National Land Agency photograph)

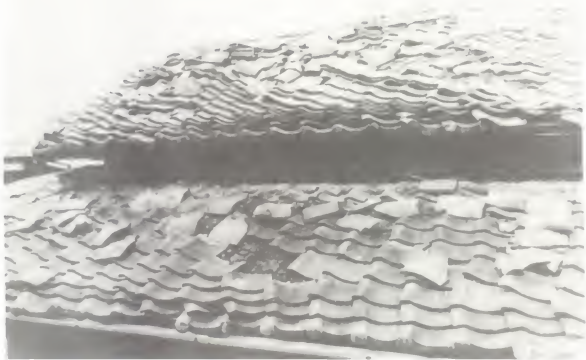
from the remainder of the structure due to ground settlement. There were many instances where tile roofs were badly damaged even when the structure remained standing (Figure 5.86).

Figure 5.86 Typical damage to tile roofs in Sendai (Japan National Land Agency photograph)

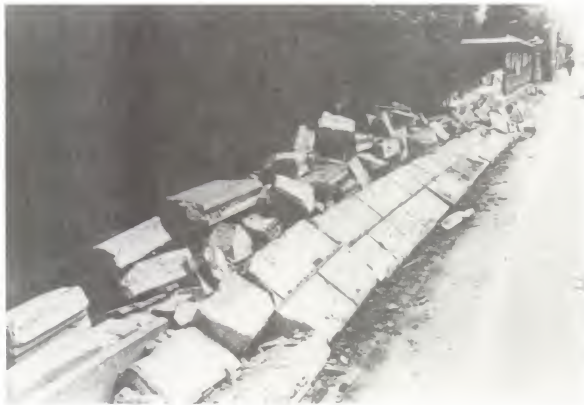
Two examples of collapsed masonry-unit walls are shown in Figures 5.87 and 5.88. The wall shown in Figure 5.87 was not reinforced, and crumbled during the earthquake. The wall in Figure 5.88 contained reinforcement but was not anchored adequately to its foundation and toppled over practically as a unit.

Figure 5.87 Failure of unreinforced concrete masonry wall in Sendai (Japan National Land Agency photograph)

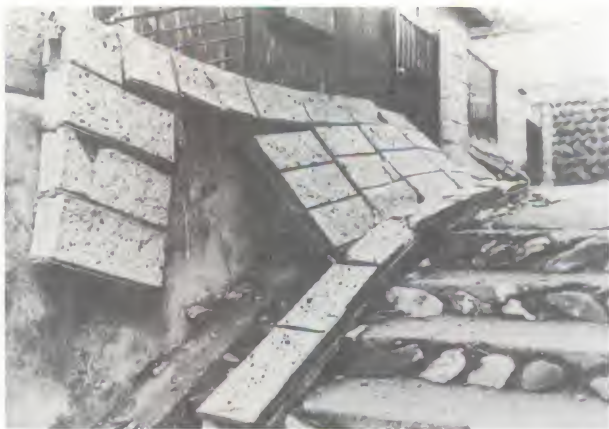
Figure 5.88 Failure of a reinforced concrete masonry privacy wall in Sendai.  
(Japan National Land Agency photograph)

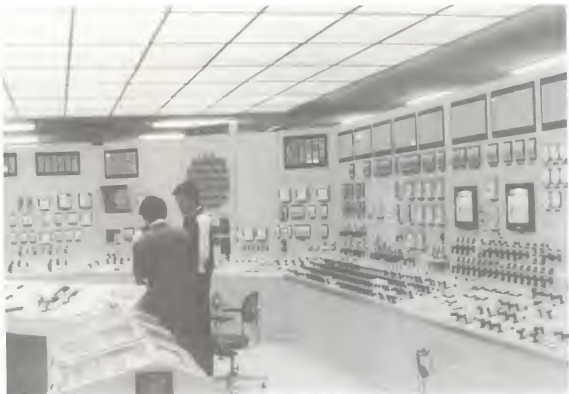
**Figure 6.10** Fukushima Nuclear Power Plant. Broken ceramic insulators were the only damage reported for the site. The damaged insulators had been replaced, as illustrated above, within hours after the earthquake and before the reconnaissance visit.

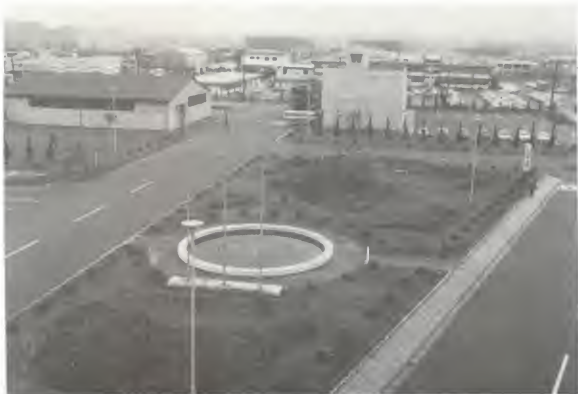
Figure 6.14 New Sendai Power Plant; Tohoku Electric Power Company: A view of the entrance area to the power plant showing settlement of fill and subsequent repair work to the pavement. The pavement settled approximately 15 cm (6 in) and was primarily in the vicinity of a backfilled underground pipeline.
